CERL Special Report 99/87 November 1999

Cape Cod Railroad Bridge Coating Field Test Results

Alfred D. Beitelman

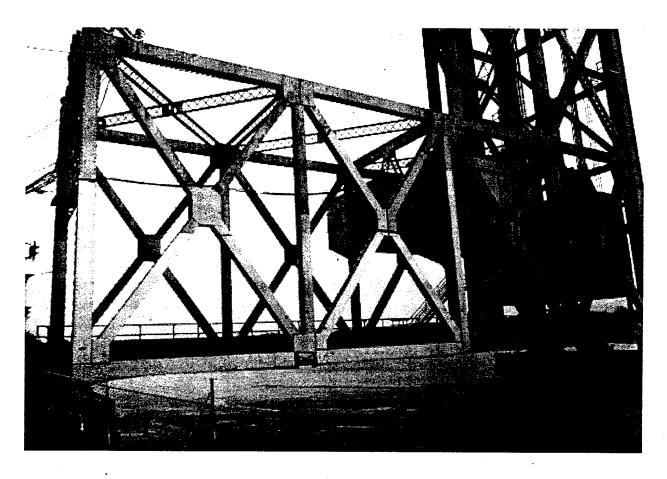
Figure 2. Segment of railroad bridge over Cape Cod Canal used for 1994 coatings field test.
